September 16, 2014  
URS Project Number 15303807

Department of Public Works  
City of Reading  
Reading, PA 19601

Subject: **Final Dam Portfolio Management Report  
Reading, Pennsylvania**

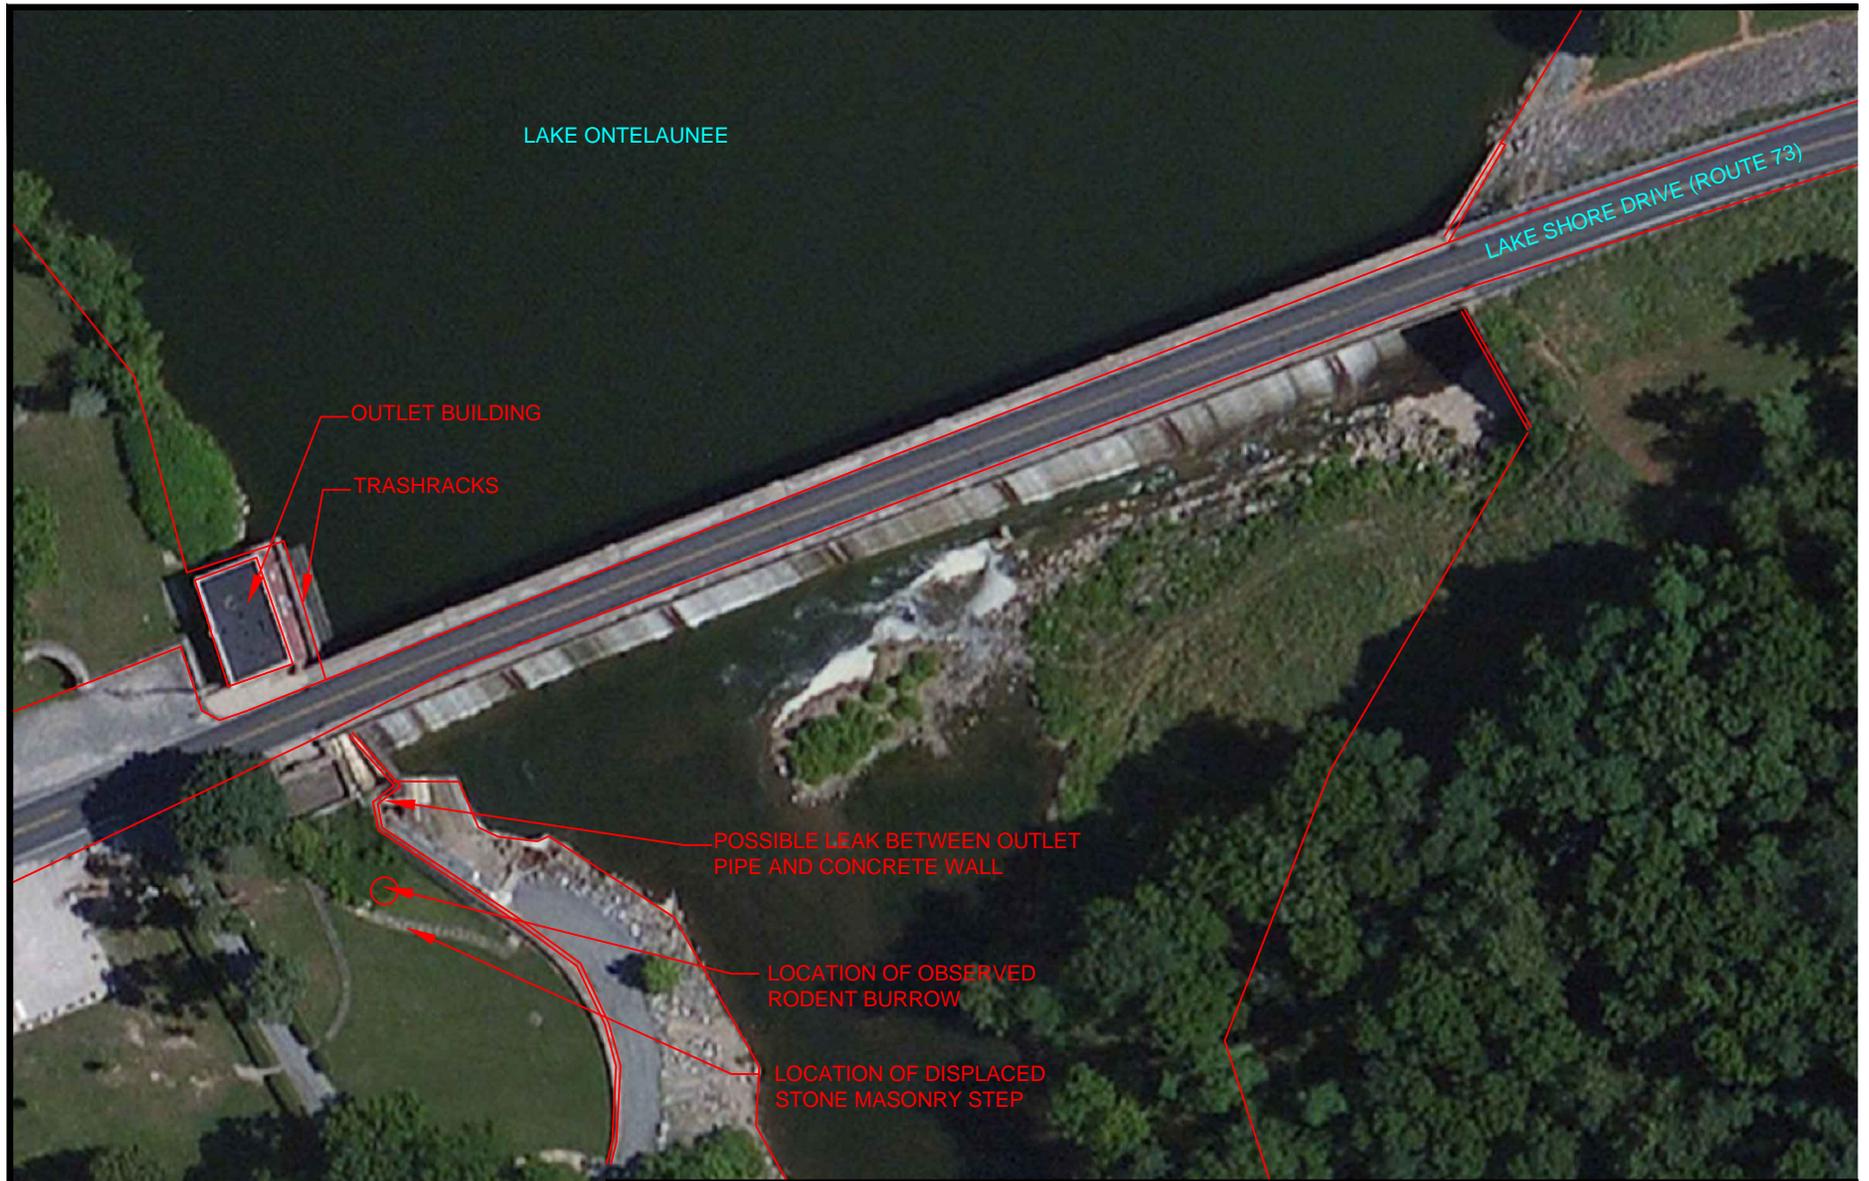
TITLE LAKE ONTELAUNEE – SPILLWAY	
<b>URS</b>	PROJ NO 153
	FIGURE FIG

POSSIBLE LEAK BETWEEN OUTLET PIPE AND CONCRETE WALL

LOCATION OF OBSERVED RODENT BURROW

LOCATION OF DISPLACED STONE MASONRY STEP

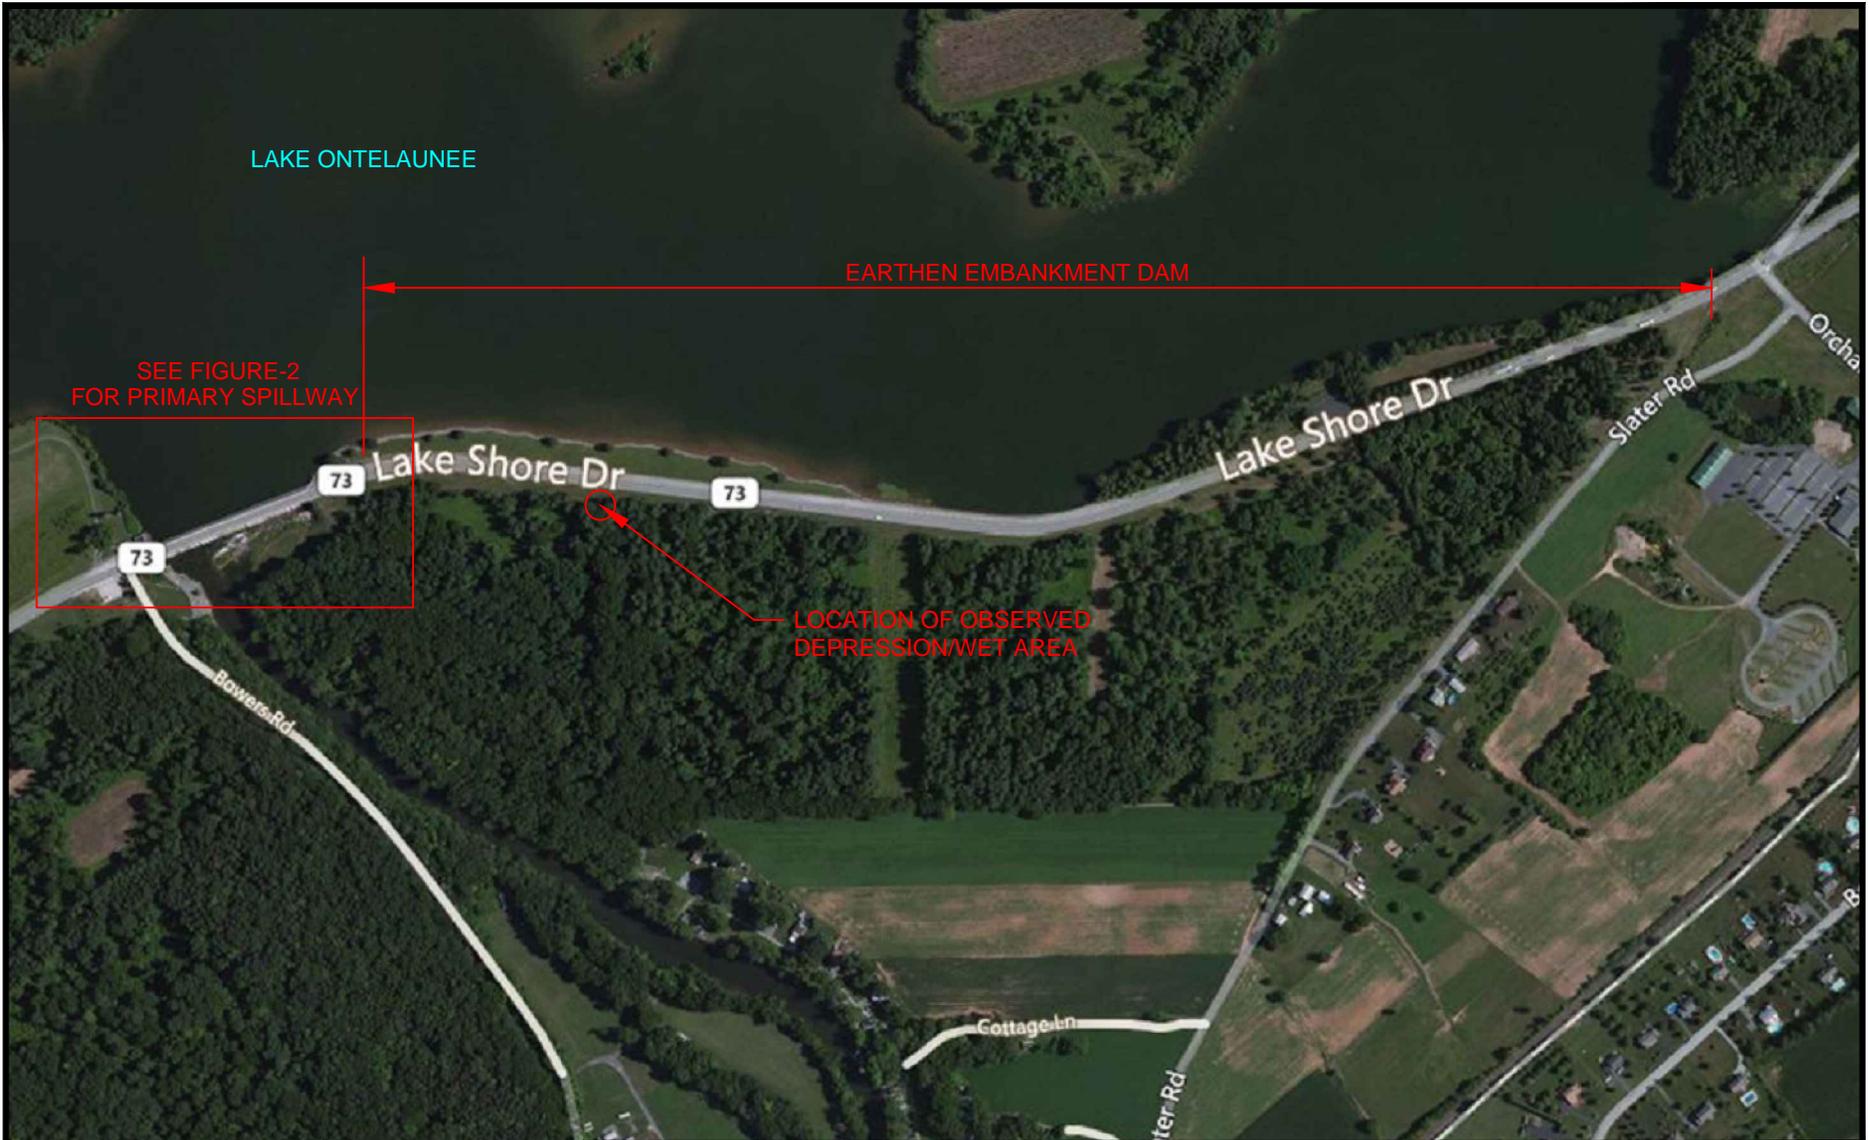
TITLE LAKE ONTELAUNEE – OVERVIEW

LOCATION OF OBSERVED  
DEPRESSION/WET AREA
