September 16, 2014  
URS Project Number 15303807

Department of Public Works  
City of Reading  
Reading, PA 19601

Subject: **Final Dam Portfolio Management Report  
Reading, Pennsylvania**

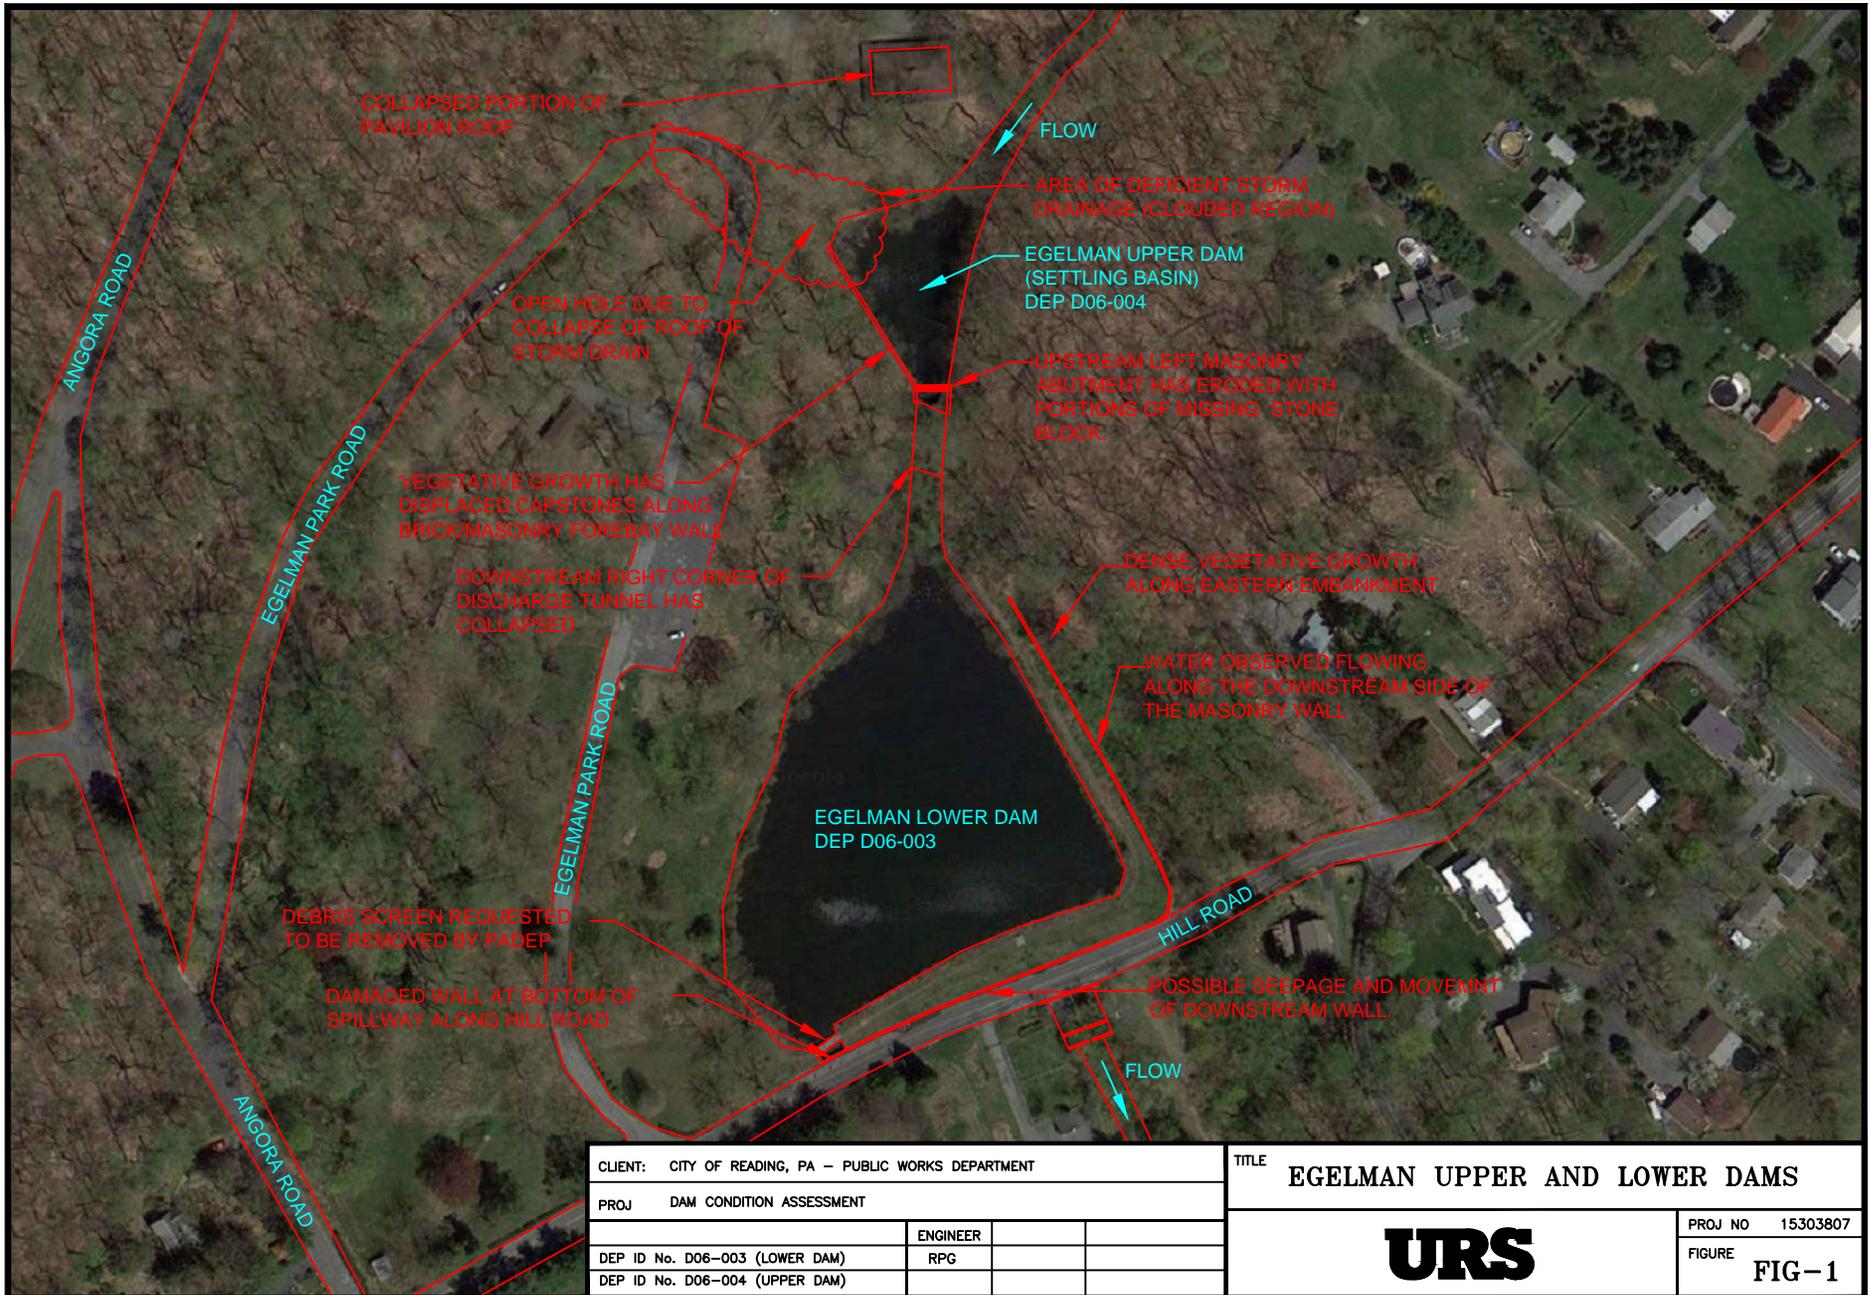
TITLE <b>EGELMAN UPPER AND LOWER DAMS</b>	
<b>URS</b>	PROJ NO 15303807
	FIGURE <b>FIG-1</b>

POSSIBLE LEAK BETWEEN OUTLET PIPE AND CONCRETE WALL

LOCATION OF OBSERVED RODENT BURROW
